Learn from the mistakes of others; you'll not live long enough to make them all yourself . . . **Issue 4/2003**

Pilot Error or Poor Management?

On October 15, 2001, a Piper PA-31 departed Yellowknife, Northwest Territories, at 20:43 on a night IFR charter flight to Fort Liard. One pilot and five passengers were on board. On arrival at Fort Liard, in conditions of moderate to heavy snow, the pilot initiated a non-directional beacon (NDB) approach with a circling procedure for Runway 02. At about 22:33, the aircraft struck a gravel bar on the west shoreline of the Liard River, 1.3 NM short of the threshold of Runway 02, and 0.3 NM to the left of the runway centreline. The aircraft sustained substantial damage, but no fire ensued. Three passengers were fatally injured, and the pilot and two passengers were seriously injured. This synopsis is based on the Transportation Safety Board of Canada (TSB) Final Report A01W0261.

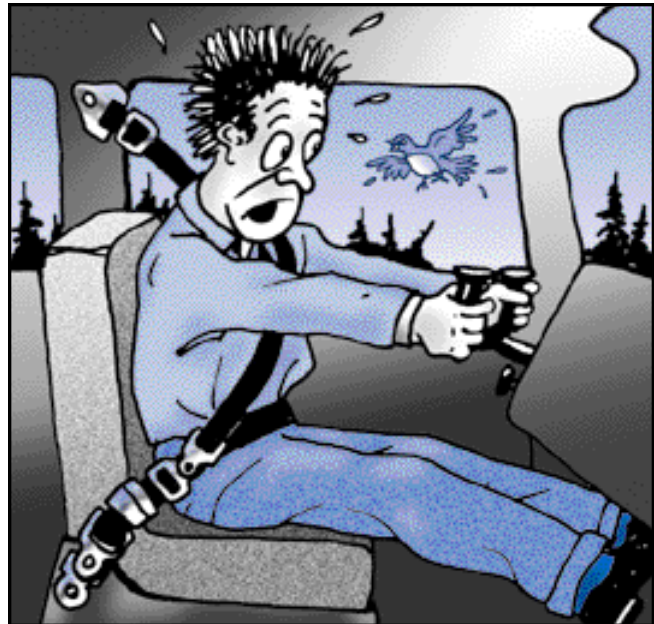
Most people will agree that the lap belt is important during takeoff and landing and when there is an encounter with turbulence, but few recognize the importance of wearing the shoulder belt during the most dangerous phases of flight—takeoff and landing. Wearing the shoulder belt is the best insurance against injury should there be an abrupt end to the flight. Every aircraft should have shoulder harnesses installed. It is just as important as having an airworthy aircraft. You should inspect them for wear regularly and ensure that they always function properly. Check the fabric of the belts regularly, especially where it contacts the metal guides and metal locking mechanisms, and forward the assembly to the manufacturer for repairs at the slightest hint of tear or a frayed section. Any damaged area will reduce the assembly's design strength and may be responsible for serious injury

in case of a mishap. As pilot-in-command, make sure that the preflight checklist requires that the crew and passengers have their shoulder harness fastened before takeoff and landing. If your aircraft does not have shoulder harnesses, you should have them installed as soon as possible. They do not interfere in any way with your duties, but are the best insurance policy you can have in case of an accident. Be safe—always. ✈️
